## Electric Locomotives in Two Wrecks

Man Failure and Act of Providence Are Causes of Two Accidents on C., M. & St. P. Mountain Division—Electrical Equipment in No Way at Fault

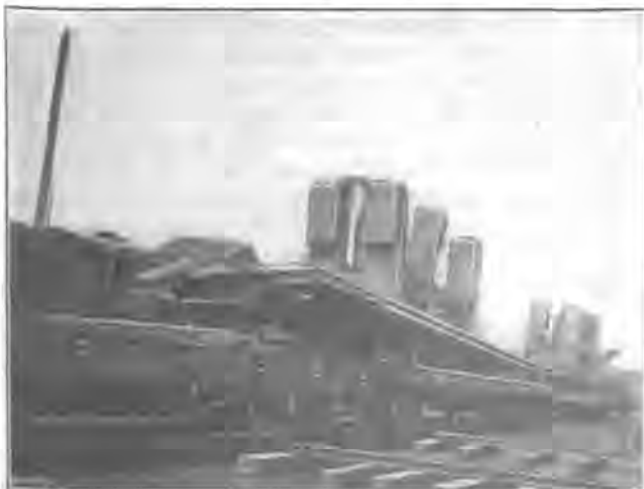
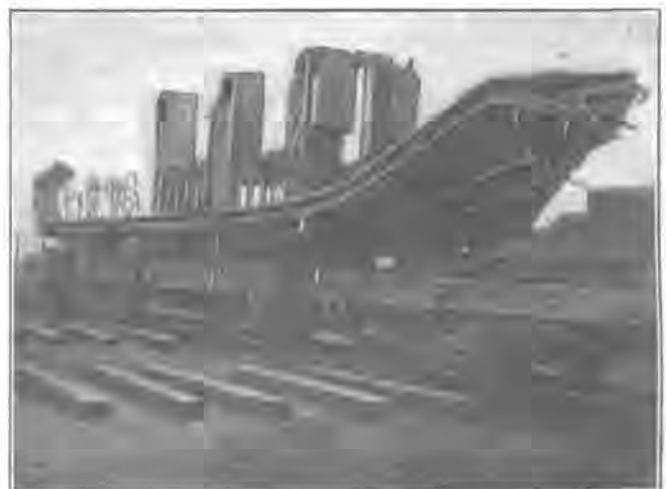
PARTS OF WRECKED MILWAUKEE LOCOMOTIVES AS RETURNED TO THE WEST TACOMA SHOPS  
These underframes are being straightened and the rehabilitated locomotives will soon be in regular service.

These locomotives, Nos. 10,208 and 10,240, rounded a curve at 15 or 16 miles per hour and entered the sunken track, rolling and sliding down the slope to a point about 400 ft. below. The two engineers and two firemen carried down with them were practically uninjured. An instructor and brakeman had to be taken to a hospital, but they recovered. The cabs of both locomotives were almost completely wrecked. The underframes were badly bent and twisted and the sheeting on the sides and roof was stove in by hitting against rocks and trees as the engines slid down the embankment so that it was practically beyond reclamation. Inside the cabs the motor-generator sets, rheostats, control equipment, air compressors, wiring, etc., were practically all torn

from their fastenings and damaged more or less. The engine trucks, short and long main trucks, driving wheels and motors of both locomotives were very little damaged. The brake rigging on one engine was little damaged, while that on the other was damaged to some extent.

With the two wrecked locomotives some 400 ft. below grade, it was some problem to salvage them. This work was finally accomplished by loading the engines by pieces on wagons and carting them to North Bend on the Everett line, a distance of 7 miles, where they were loaded on cars and sent to the Tacoma shop.
