INTERSTATE COMMERCE COMMISSION

ACCIDENT ON THE

CHICAGO, MILWAUKEE, ST. PAUL & PACIFIC RAILROAD

INVESTIGATION NO. 2278

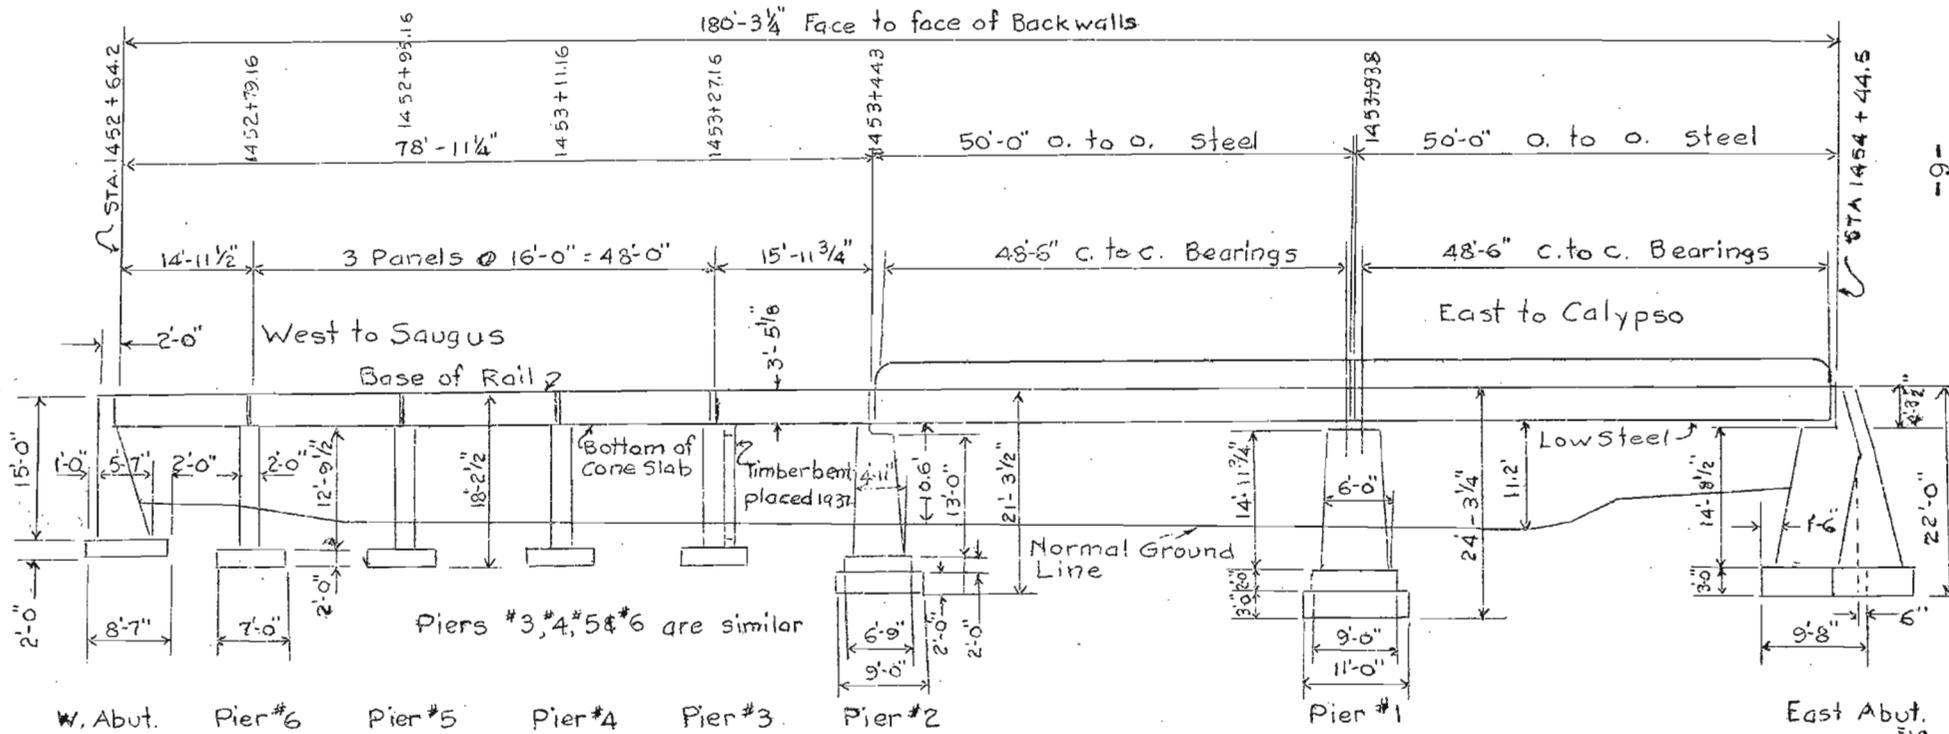
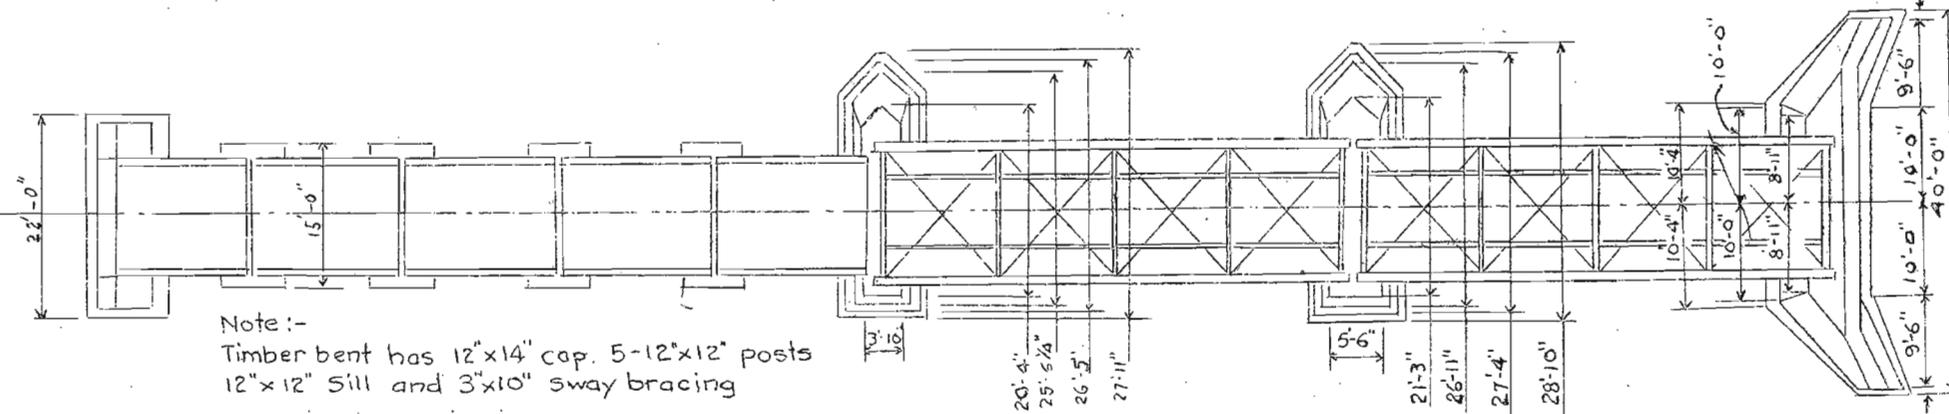
Inv. No. 2278.
 C., M., St. P. & P. R. R.,
 Saugus, Mont.,
 June 19, 1938.

Note :-
 Timber bent has 12"x14" cap. 5-12"x12" posts
 12"x12" Sill and 3"x10" sway bracing

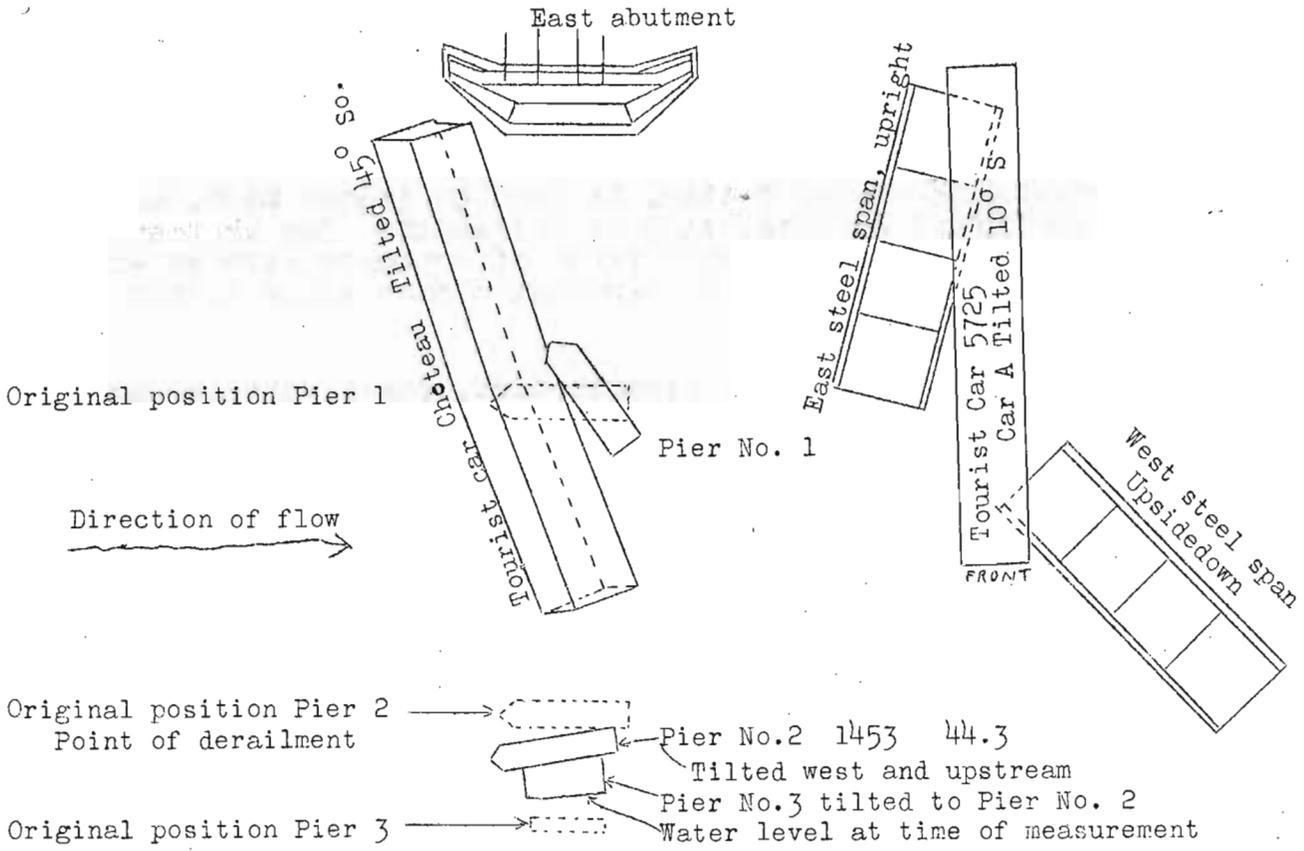
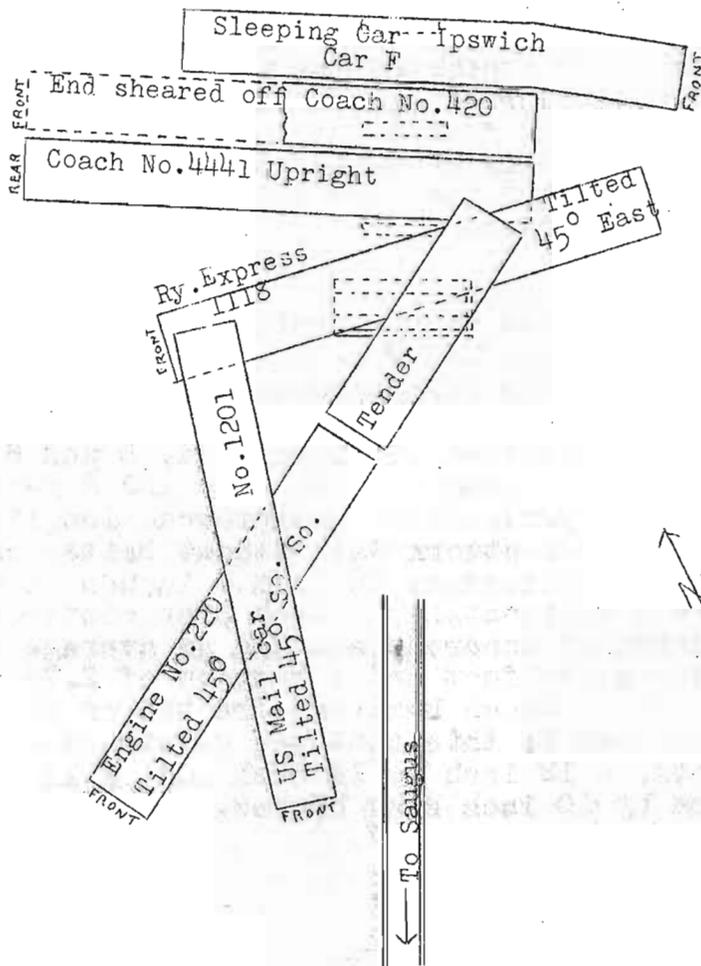
Pier No. 4, sheared off

Pier No. 5, sheared off

Pier No. 6, sheared off

West abutment, sheared off

The east abutment of the bridge was practically undamaged. Pier 1 stood at a 45° angle to its normal position; piers 2 and 3 were tipped together, midway between their normal positions; piers 4, 5 and 6, and the west abutment were sheared off. The two girder-spans were in the stream bed about 50 feet south of the bridge.
