INTERSTATE COMMERCE COMMISSION

ACCIDENT ON THE

CHICAGO, MILWAUKEE, ST. PAUL & PACIFIC RAILROAD

INVESTIGATION NO. 2278

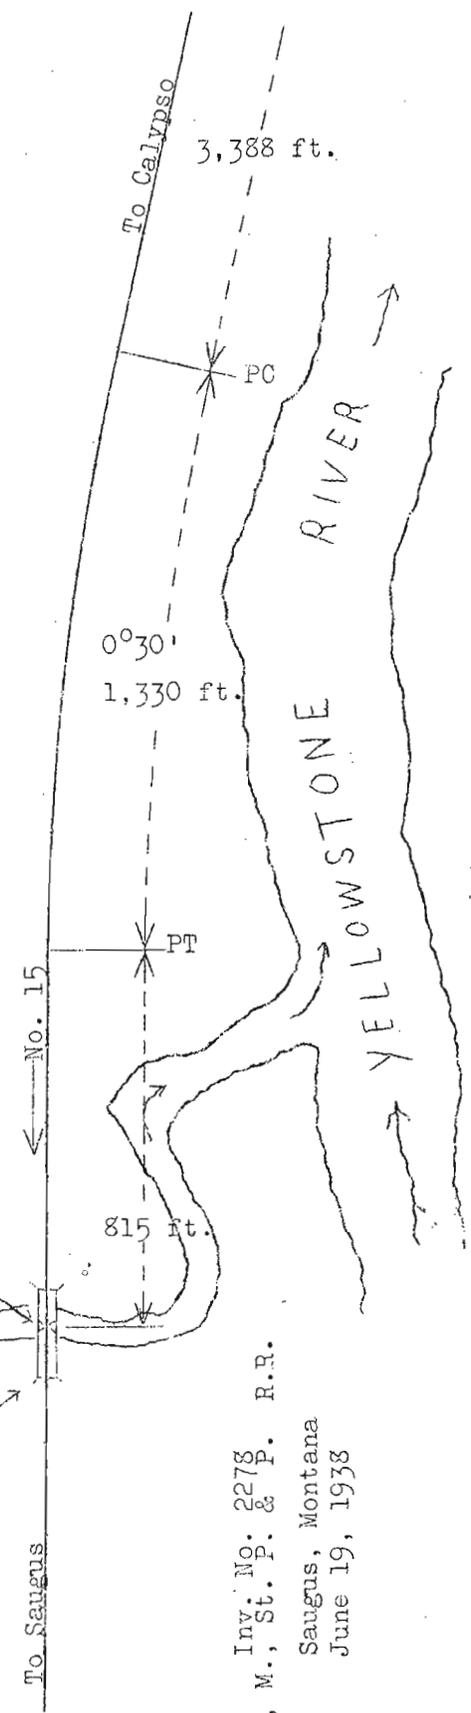
Inv. No: 2278
 C., M., St. P. & P. R.R.
 Saugus, Montana
 June 19, 1938

Bridge AA-438, constructed in 1913-14 to replace a pile and timber trestle which was originally built at this location in 1907, was a single-track steel and reinforced-concrete structure having an approximate length of 180 feet. The structure was supported by two abutments and six intermediate piers. East to west, it consisted of two 50-foot through-plate girder spans and five reinforced concrete trestle-slab spans, each of the latter measuring approximately 16 feet in length. The steel girders rested on the east abutment and piers 1 and 2, while the concrete-slab spans rested on piers 2 to 6 and the west abutment. The girders were constructed of 72-inch by 3/8-inch web plates with full length 14-inch by 1/2-inch top and bottom cover plates, each reinforced by an additional 14-inch by 1/2-inch cover plate, 28 feet 8 inches in length. Flange angles were 6-inch by 6-inch by 1/2-inch "L" sections and stiffener angles were provided at approximately 4-foot intervals. The girders rested on abutment and pier bed-plates, having 48 feet 6 inch center-to-center bearing.
