REPORT OF THE DIRECTOR
BUREAU OF SAFETY

ACCIDENT ON THE
CHICAGO, MILWAUKEE, ST. PAUL AND PACIFIC RAILROAD

MARVIN, S. DAK.

INVESTIGATION NO. 2443

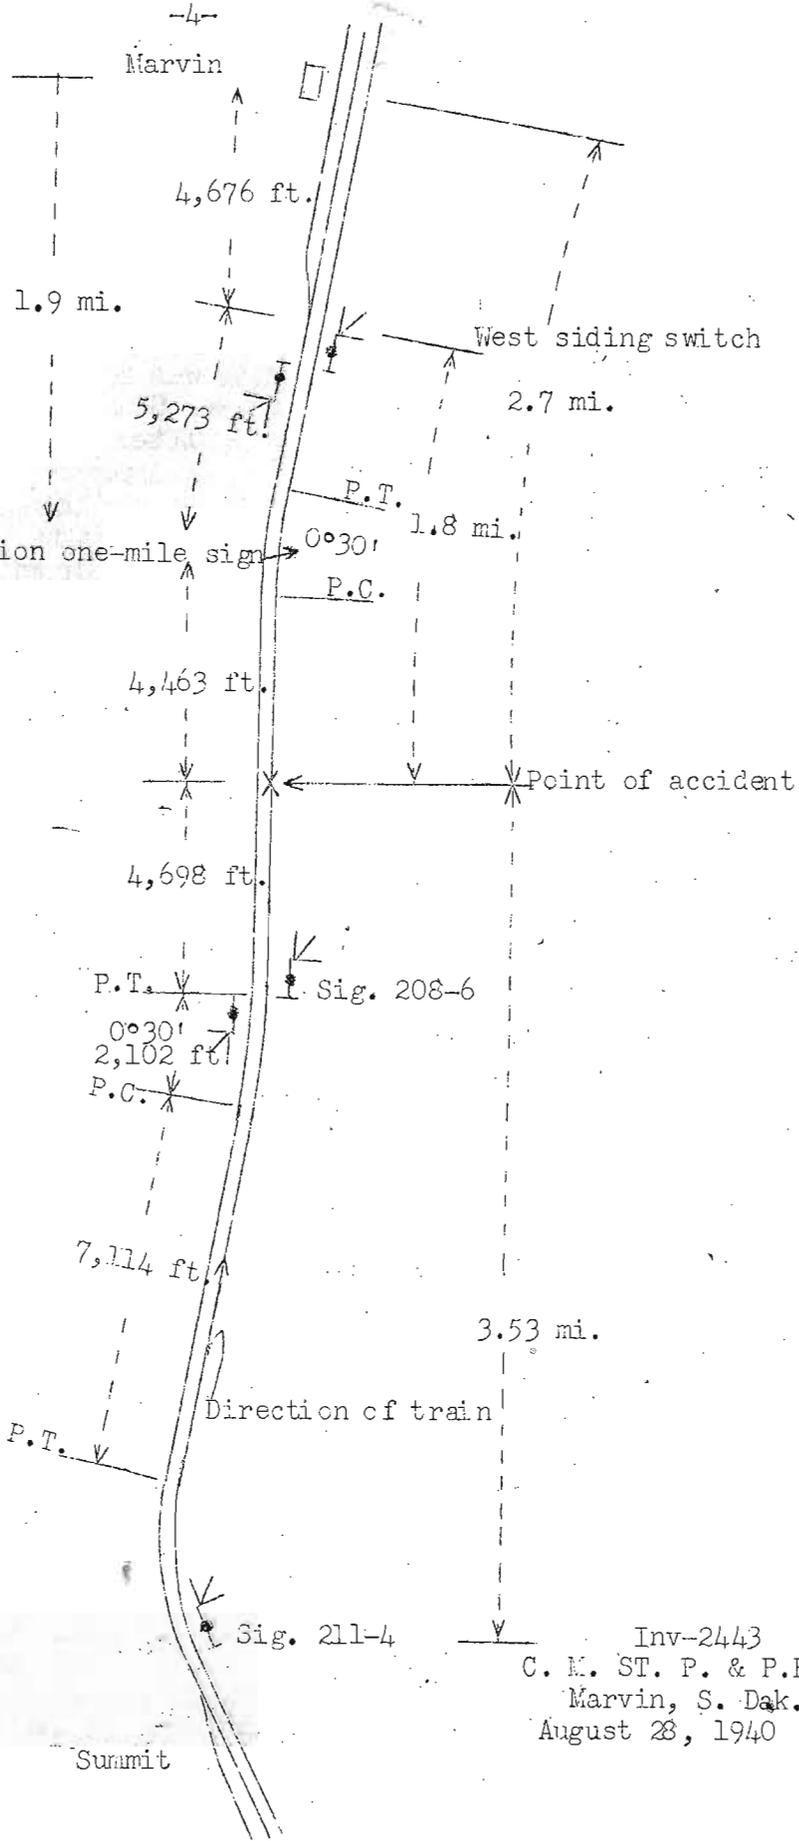
Inv-2443
 C. M. ST. P. & P.R.R.
 Marvin, S. Dak.
 August 28, 1940

- Montevideo, Min.. 71.6 mi.
- Marvin, S. Dak. 2.7 mi.
- x Point of accident 4.5 mi.
- Summit 77.9 mi.
- Aberdeen 0.5 mi.
- Aberdeen Yard, S. Dak.

Signals 211-4 and 208-6 are located 3.53 miles and 0.89 mile, respectively, west of the point of accident. These signals are of the 3-position, upper-quadrant, semaphore type. Aspects, indications, and names are as follows:
