THE CONTACT SYSTEM OF THE BUTTE, ANACONDA & PACIFIC RAILWAY

By J. B. Cox

RAILWAY AND TRACTION ENGINEERING DEPARTMENT, GENERAL ELECTRIC COMPANY

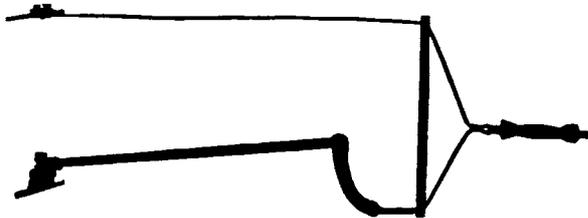
Fig. 3. Flexible Pull Off for Pantograph Collector

As a very large percentage of the trackage to be electrified is of curve construction varying anywhere from a tangent to 22 deg. curvature, it was necessary to give most careful attention to the design of a new pulloff. The efforts in this direction created an entirely new pulloff by means of which the messenger and trolley wires are held in position by separate clamps. From each clamp runs an individual pulloff wire with a strut between them that maintains the pull parallel to the horizontal plane of the trolley wire. This arrangement allows of a free vertical movement independent of the messenger, see Fig. 3.

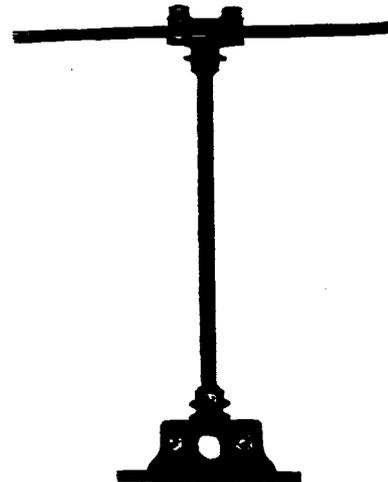
Fig. 5. Rigid Catenary Pull Off

Rigid pulloffs, as shown in Fig. 5, were used at some points but were found to be subject to

much the same objections as the double pulloffs because of the sparking due to similar reasons.

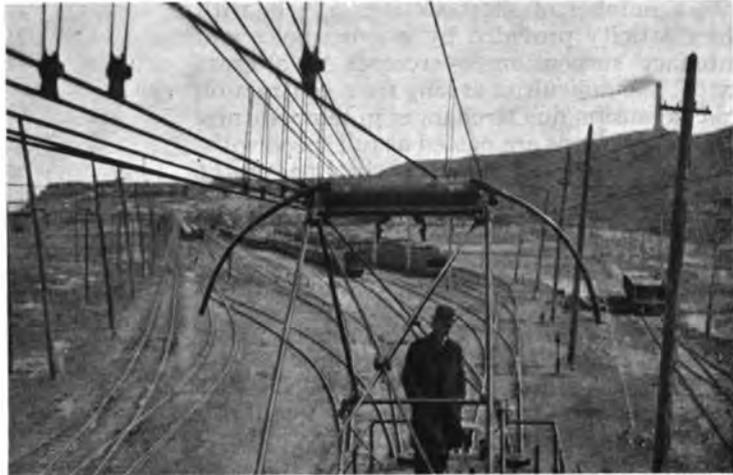
Fig. 8. Pantograph in Contact with Six Trolley Wires at a Switching Point

through wires and then gradually brought down to that plane a short distance ahead of the switching point from where they were gradually carried away following over the switching track. At some points in the yards, where the parallel tracks left the ladder track at close intervals, as many as six sets of wires are in the same horizontal plane and all the trolley wires make contact with the roller simultaneously. See Fig. 8.

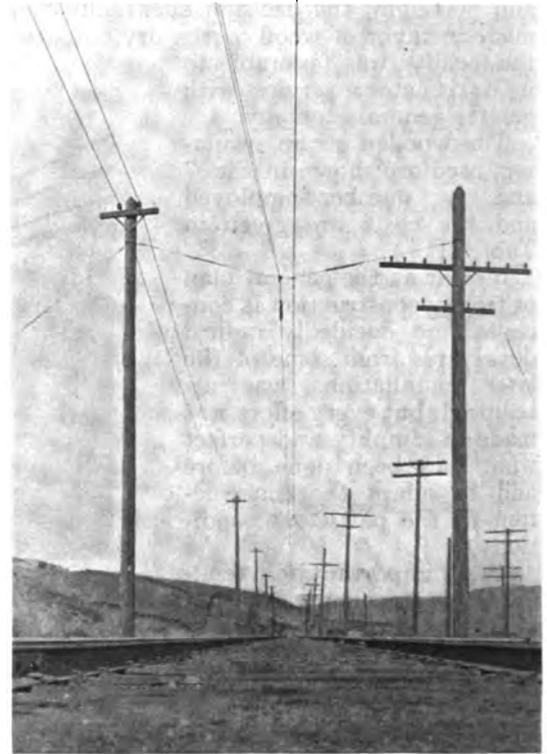
Fig. 10. The Arrangement of an Air Section Insulator

Tests were made by cutting the current off one section and running a locomotive from the live section onto the dead section at slow speed with heavy current to see if the arcing between the pantograph and the live trolley wire would be injurious. The arcing was surprisingly small and not of a nature to do serious harm to either wire or roller. Fig. 10 shows the general method of installation.

Air section insulation was used at all points where it was practicable and has been found to be advantageous from every point of view. Instead of inserting wooden insulators in the trolley line where sectionalization was desired, the ends of the wires of each section were made to overlap each other the length of a pole spacing. The two sets of wires are carried in approximately the same horizontal plane but about 12 inches apart for a few feet in the middle of the span, from which point the dead ends of the trolley wire are gradually

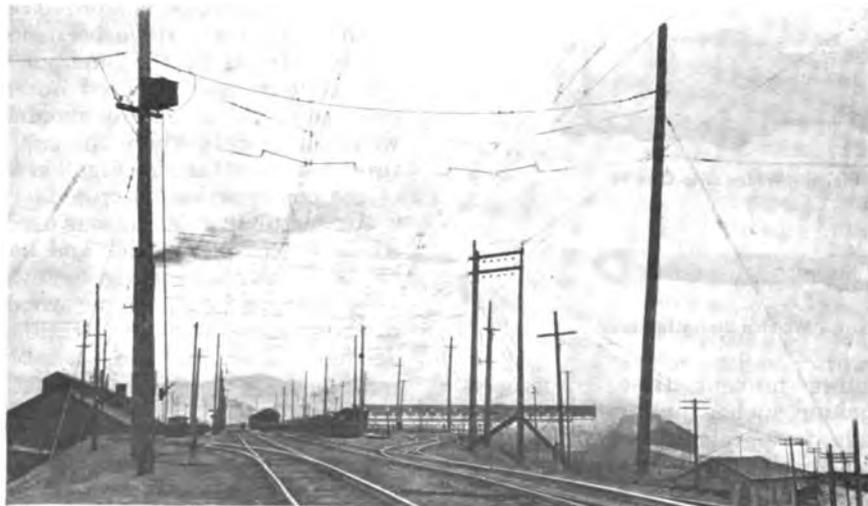
Fig. 9. View of the Contact System at the Stock Bin Yard

This construction has proved entirely satisfactory and there have been no instances of trouble caused by the omission of deflectors. The construction adopted not only lessened the cost of the work but avoided much extra weight at points where the supporting structure was most taxed. Fig. 9 is an illustration of the construction described.

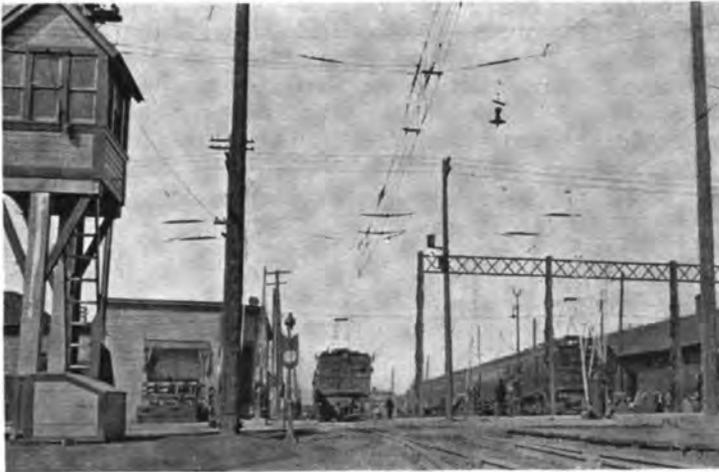
Fig. 12. General Arrangement of the Electrical Connections at a Street Railway Crossing

heavy currents were broken under the conditions heretofore described. Fig. 12 shows the general arrangement of the electrical connections for these street railway crossings.

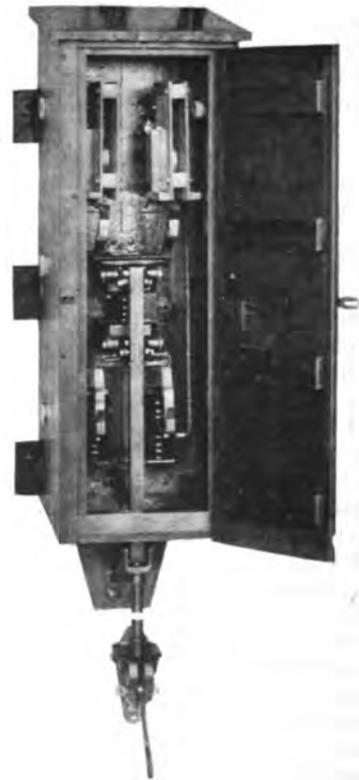
Fig. 13. A Commutating Switch

Practically no trouble was experienced at these points after the watchmen became accustomed to their new duties, but at the less frequently used crossings where the train crews operated the commutating switches some troubles were experienced with the switches in addition to that already noted with the section insulators. These switches were not expected to open heavy currents for the operators were expected to hold them in until the locomotive had entirely cleared the protecting zone. Occasionally this was not done or to aggravate matters the switch was allowed to only partly open while the locomotive was still in the protecting zone, and when arcing was noticed in the switch box the handle was dropped and the switch badly burned. These commutating switches are shown in Fig. 13. At one point where this trouble occurred a second time, electrically

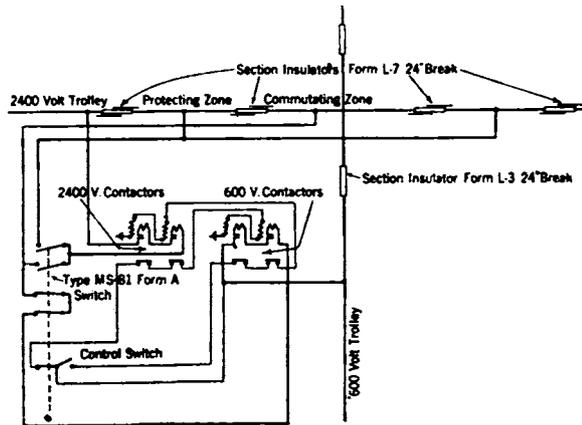
Fig. 14. Diagram of Connections at a 600-volt Street Railway Crossing showing commutating arrangement and protection from 2400-volt System with Electrically Operated Contactors in Series with Regular Commutating Switch

operated contactors were placed in series with the ordinary operating switch on both the 2400-volt and 600-volt circuits, the two sets of contactors being so interlocked as to render it impossible for both to be energized at the same time. See Fig. 14.

No further troubles were experienced from this cause after the installation of the contactors. These switches have been redesigned for future installations. After the men had become familiar with the operation of the switches there were very few instances of trouble even with the original switches.

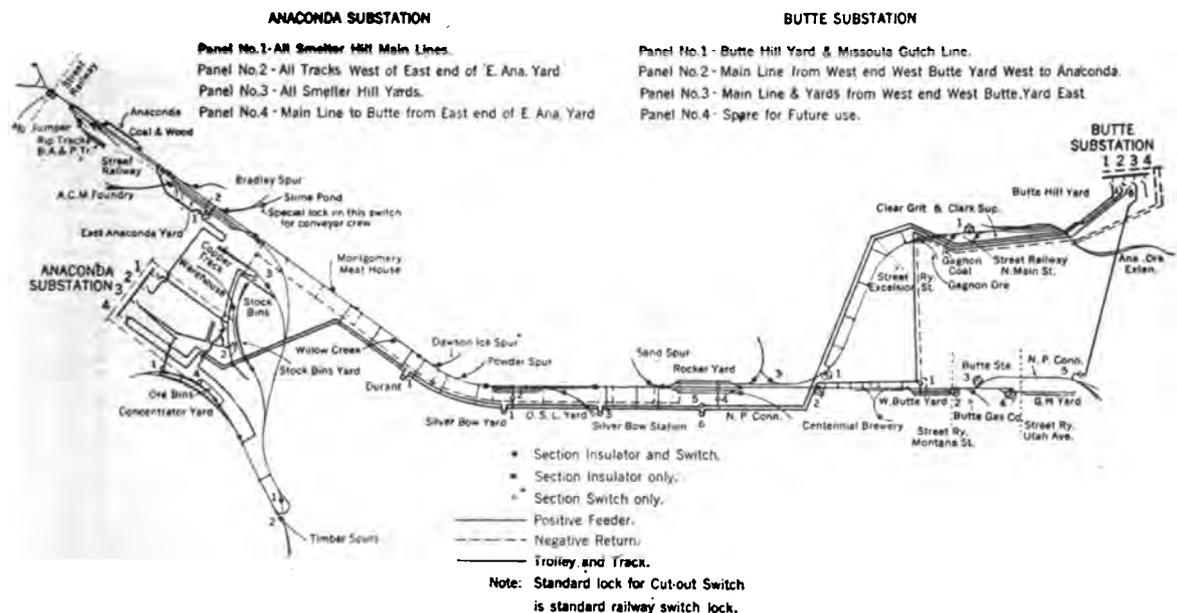
Fig. 15. Diagram Showing Sectionalization of Trolley and Feeder Systems

The trolley line was sectionalized at intervals as shown in Fig. 15 which also shows the final feeder arrangement. The sectionalizing switches were placed in asbestos lined wooden boxes and located on trolley poles well out of reach from the ground. An operating lever was located at a convenient point on the pole, and at a suitable distance from the ground for ease in handling. It is provided with a standard track switch padlock so that no extra key is required by trainmen for its operation. The operating handle is connected with the switch blade by a wooden rod which provides adequate insulation.

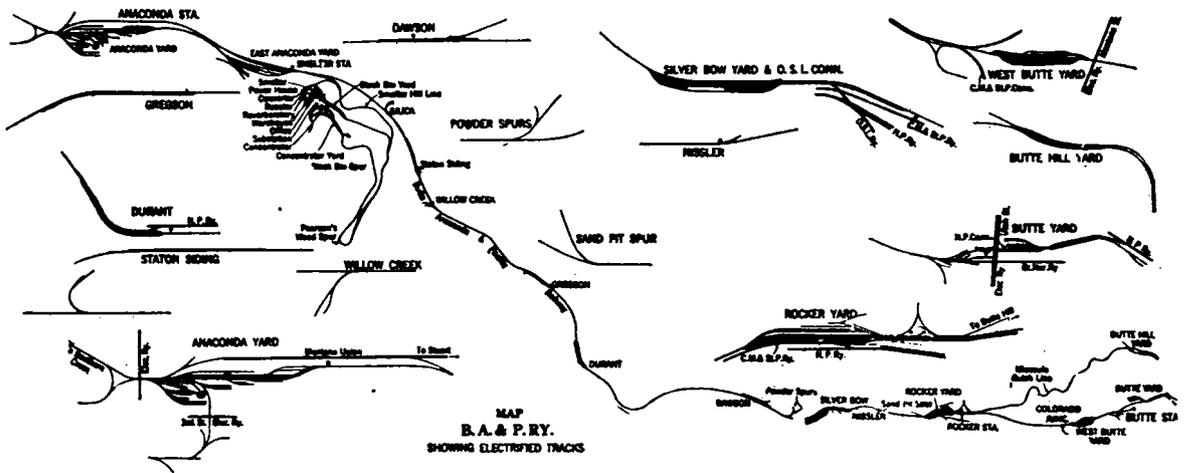
Fig. 16. Diagram of the Electrified Section of the Butte, Anaconda & Pacific Railway

principally of 8 yards located at Anaconda, East Anaconda, Silver Bow, Rocker, West Butte, and Butte on the main line and the Concentrator Bins, Storage Bins, and Butte Hill Yards on branch lines. Fig. 16 shows in

map form the relative location of these yards and spurs as well as the number and arrangement of the tracks, etc.

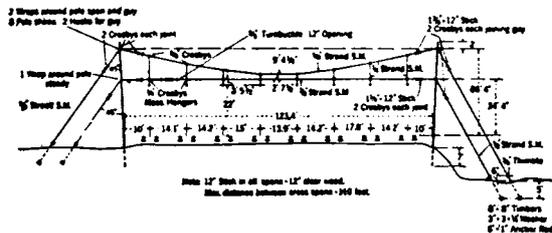
Fig. 17. Diagram showing Dimensions of a Cross Catenary Span for eight tracks

The East Anaconda Yards contained 12 tracks (including those of the main line) aggregating approximately 5 miles. These are the largest yards on the system. Eight of these tracks run almost the entire length of the yard which is approximately 1/2 mile in length. The eight tracks are spanned by double messenger span wires supported from a pole line on each side spaced approximately 110 ft. apart. The details of this construction with dimensions are given in Fig. 17.

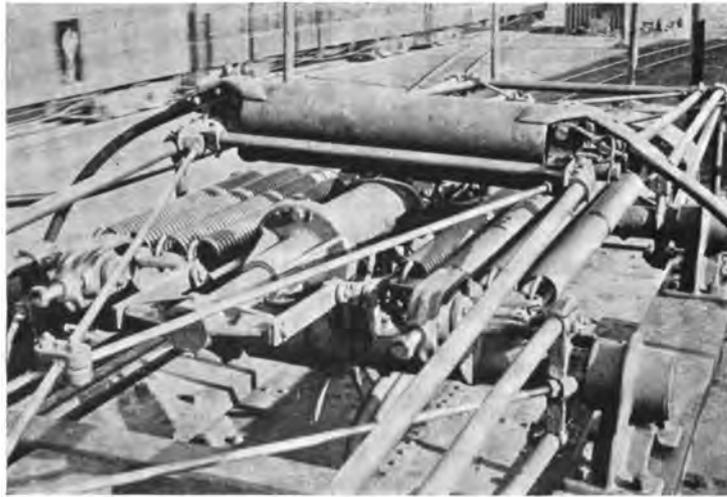
Fig. 19. A Pantograph Folded showing Revised Wear Plate

that of the roller tube as well. This difficulty was removed by the application of a new type of wearing plate which extended out slightly over the roller with a prong on either side gradually dropping below the line of the top of the roller so that the wire passed from one to the other so gradually that there was no point where the wire was inclined to catch. The lower end of this wearing plate extended out over the upper end of the horn in a similar manner and avoided the necessity of such careful fitting as had been required with the old type where butt joints were used. The new wearing plate is shown in Fig. 19.

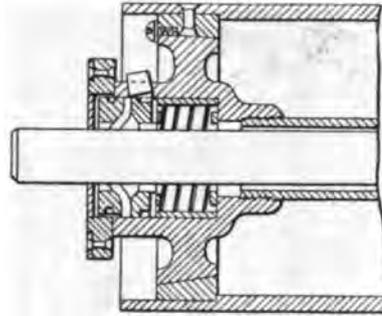
Fig. 21. Latest Type of Pantograph Roller Designed for use with Roller Bearing

In the meantime tests were being made with Hyatt roller bearings and the results had been so encouraging that it was decided to substitute these for the sleeve bearings in all the rollers as fast as the latter wore out and required to be renewed. Fig. 21 shows their installation in the later rollers designed for this purpose.

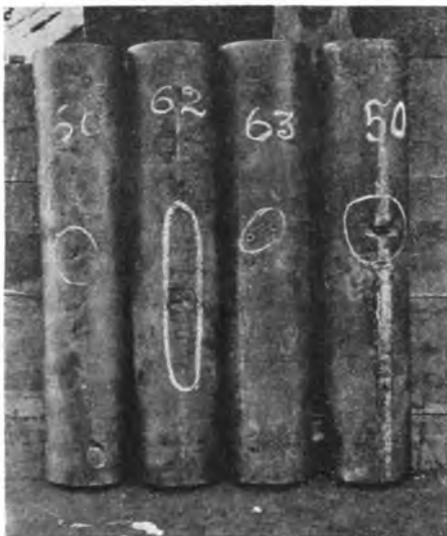
Fig. 22. View of Pantograph Rollers showing Injuries that have developed from sliding

In this connection it should be noted that eleven of the 59 abandoned tubes were removed before they had been in service many miles on account of the rollers sticking and sliding along the trolley until a groove was cut in them as shown in Fig. 22. Some of

these tubes were thus injured during the commencement of electrical operations before the defect had all been remedied, but most of them were caused by the frost freezing the roller to the T iron brace underneath, previously mentioned.
