### Construction of Two Concrete Bridges at Rosalia, Washington.

By J. F. Pinson, Chicago, Milwaukee & St. Paul Ry.

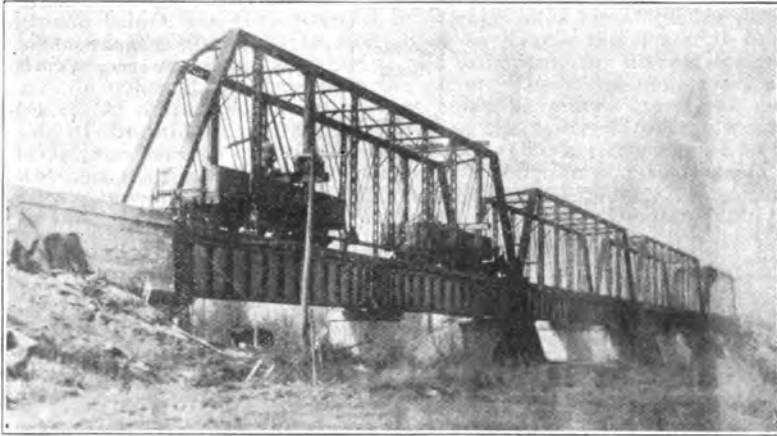
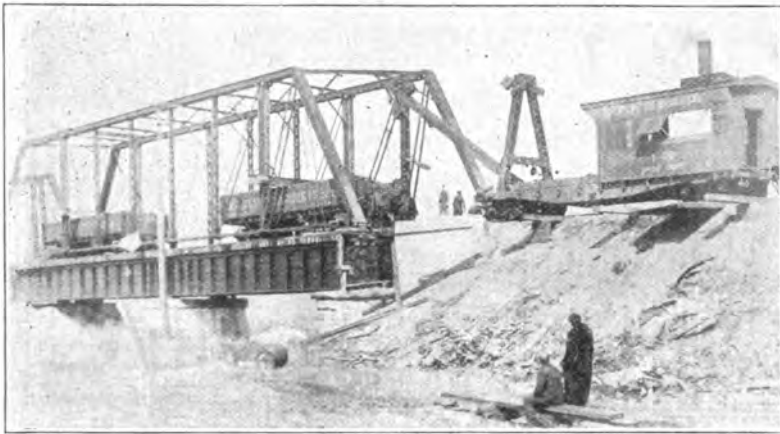
Replacing Trusses with Girders, Pere Marquette R. R.

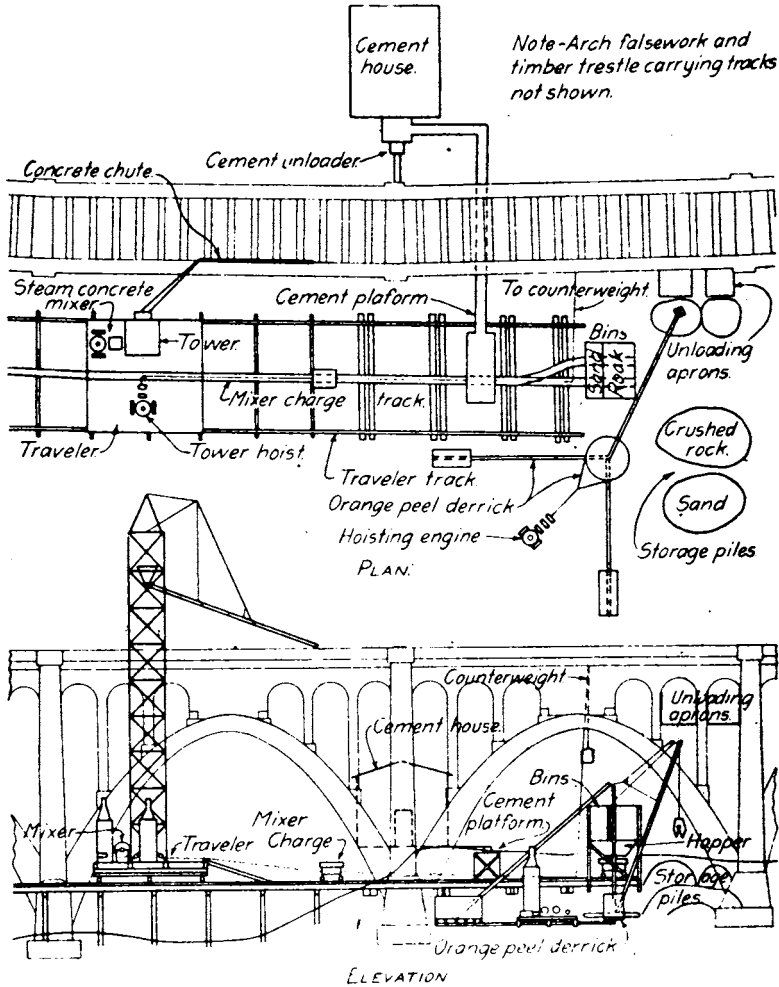
Fig. 1.--Concrete Bridges, Rosalia, Wash. Chicago, Milwaukee & St. Paul Ry.

The Concreting Plant

tened to the bridge as shown in Fig. 1. The cement was unloaded into a storage house immediately underneath and south of the bridge by means of an endless belt with a friction brake which enabled the lowering of the cement at slow speed to prevent damage to sacks by tearing or burning. The cement was then wheeled directly to the cars as they left the loading hoppers.
